Structural Assessment, Analysis, and Rehabilitation of a Masonry Aqueduct

Denis McMullan and
Douglas Bond

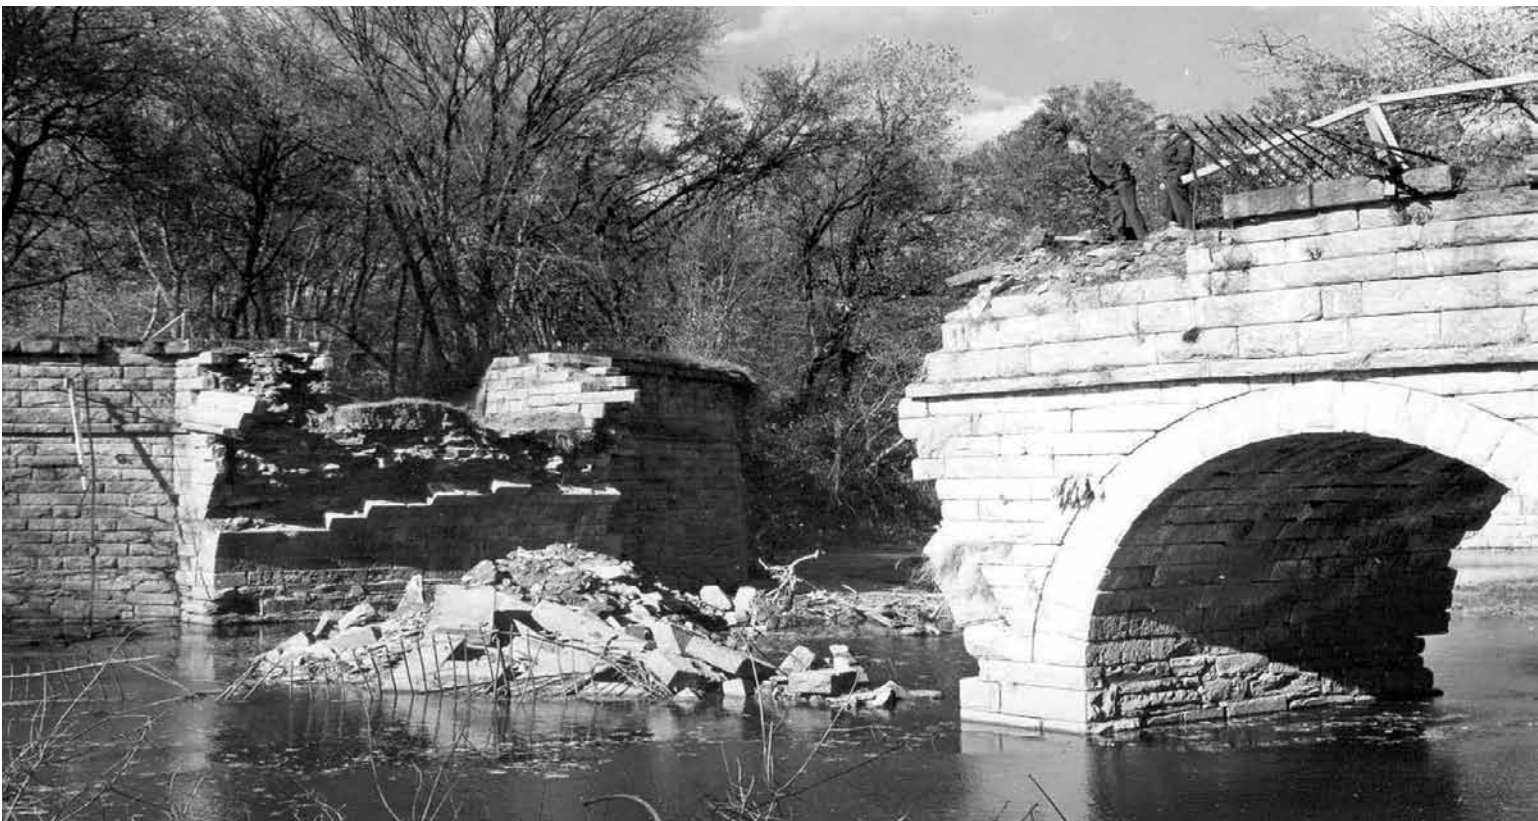
Fig. 1. Catoclin aqueduct, Lander, Maryland, collapsed center and western arches, 1973. The berm parapet and upstream spandrel wall had failed earlier. Note the railings bent in downstream direction, indicating predominate flood effects coming from tributaries and not the adjacent Potomac River. Courtesy of the C&O Canal National Historical Park Archives.

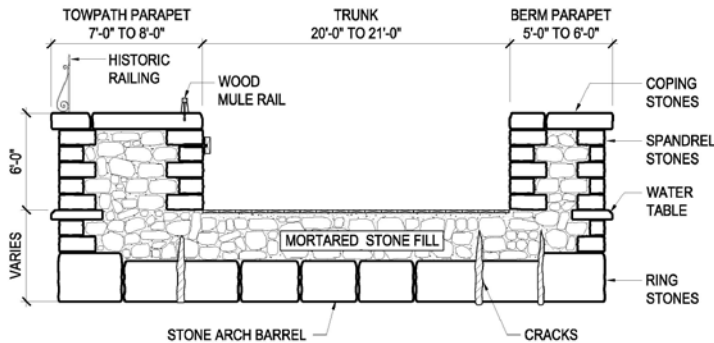
tapering to a minimum at the apex of the arch. The graceful appearance of the aqueduct also resulted from the minimal vertical dimensions from the bottom of the water trunk to the top of the arches and to the low rise-to-span ratio of the central elliptical arch.

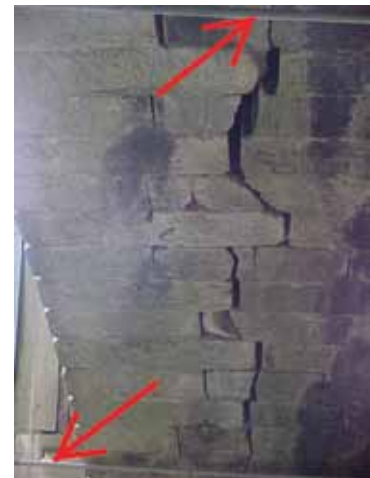
Other common problems on the C&O aqueducts are bulges in spandrel walls measuring up to 10 inches, lateral sliding of spandrel walls of up to 2 inches over the ring stones, settlement along the middle of the coping stones of up to 3 inches, and outward deflection or tilting of the parapets by as much as 4 inches. Individual arch barrel stones protrude six inches or more from many arches, and there is often a significant loss of mortar in the longitudinal joints of the arches but not in the transverse joints, where the mortar is held in position by the compression forces of the arch. Many arches have multiple cracks that have been filled with mortar and concrete in the past. Historic photographs of the Catoctin aqueduct also show significant stone damage at the spring line of the elliptical arch and the

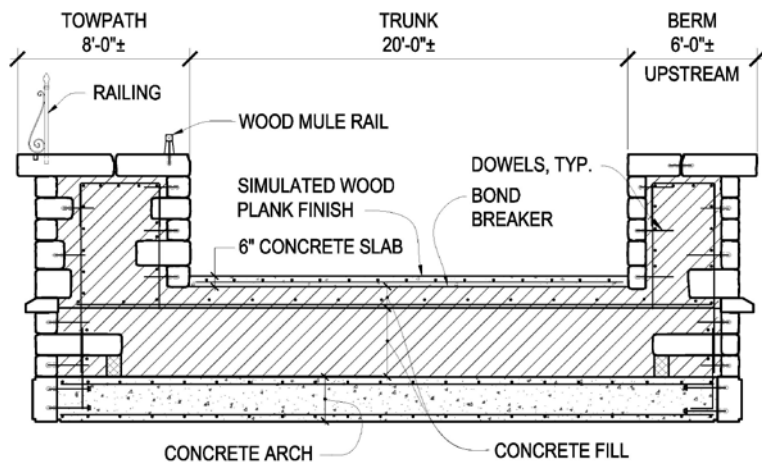
Fig. 8. Cross section of the rehabilitated Catoctin aqueduct. Note that mostly existing stones were used on downstream side, and mostly new stones used on upstream side. Also note stainless-steel dowels connecting stones to concrete fill. Drawing by Denis McMullan.

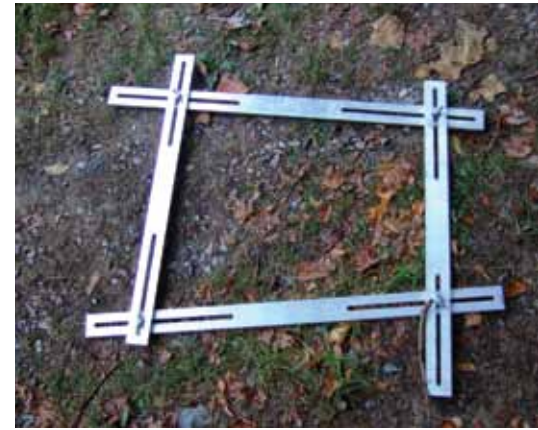
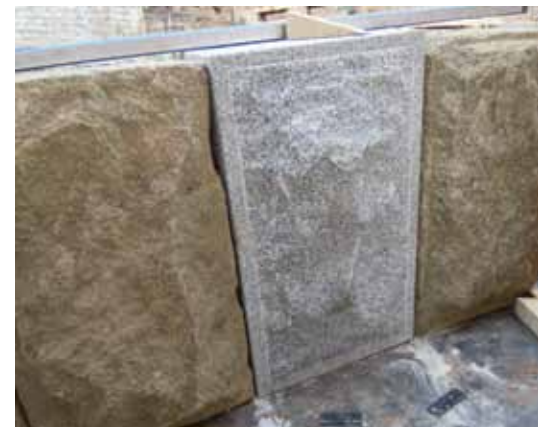
Fig. 10. New ring stone in place, 2011. Photograph by Denis McMullan.
