# Protecting and Preserving *América Tropical* in Downtown Los Angeles

This monumental 1932 rooftop mural has been conserved, protected, made accessible, and interpreted for the public by the Getty Conservation Institute and the City of Los Angeles.

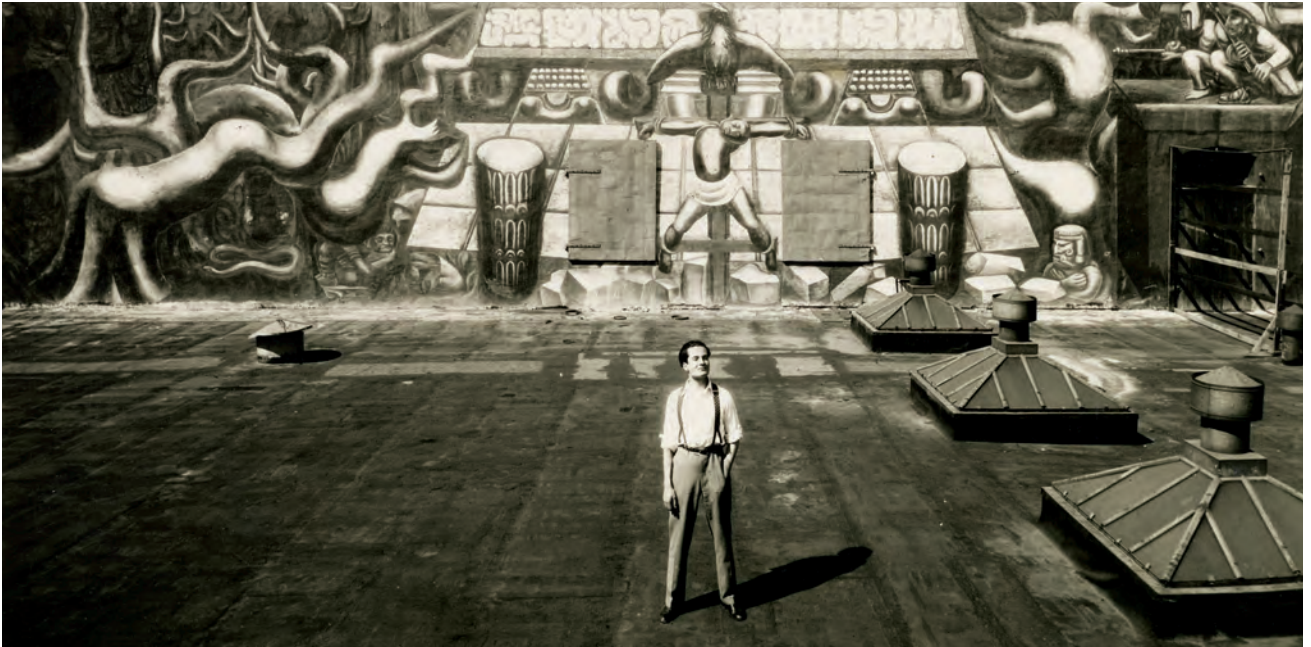
Fig. 1. *América Tropical* mural by David Alfaro Siqueiros painted in 1932 on a second-story exterior wall of the Italian Hall above Olvera Street in downtown Los Angeles, with one of Siqueiros's associates in the foreground. Photograph courtesy of the Getty Research Institute, ca. 1932, photographer unknown. Mural © 2012, Artists Rights Society (ARS), New York/Sociedad Mexicana de Autores de las Artes Plásticas (SOMAAP), Mexico City.

When the renowned Mexican artist David Alfaro Siqueiros was commissioned to paint the mural *América Tropical* (Fig. 1) on a second-story exterior wall at El Pueblo de Los Angeles in 1932, the expectation was that he would create a romanticized scene of old Mexico, in keeping with the theme of the newly developed Olvera Street, where tourists could purchase Mexican crafts along a pedestrian alley and enjoy the experience of a sleepy Mexican marketplace in the heart of the city.<sup>1</sup> Siqueiros, a radical and politically motivated artist, instead depicted an overgrown jungle, which was described by fellow artist and critic Grace Clements at the time as follows:

Huge twisted trees spread their branches in the direction of an ancient Aztec temple which lies ruined in their midst, recalling the lustful conquest of Cortez in the name of Spain and the Church. In the center of the composition, above the ruins of the temple, are the outstretched wings of world imperialism—the American eagle, beneath whose fierce eye and carnivorous claw is the lynched figure of a Mexican peon roped to a double cross. . . . And in the upper right corner from the roof of a red building two crouching men, one wearing the Peruvian cap of South America, the other the sombrero of Central America and Mexico, aim with loaded rifles at the destructive bird.<sup>2</sup>

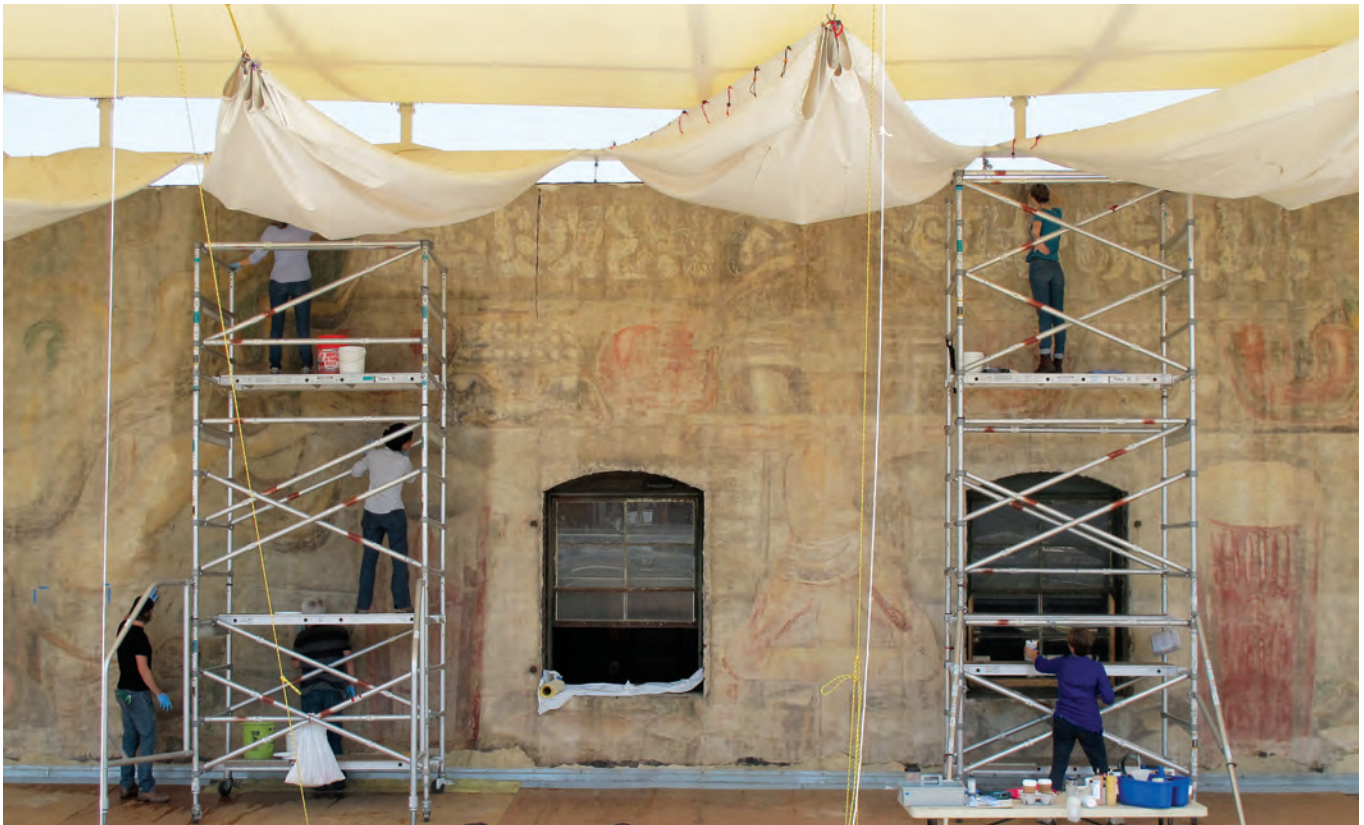
Fig. 3. The GCI conservation team performing cleaning during the 2012 treatment, which also included fills of cracks and losses, removal of tar staining, and limited aesthetic reintegration. Tar stains can be seen along the lower edge of the mural as intermittent dark spots. Photograph © J. Paul Getty Trust.

Upon completion of the shelter in 2012, the GCI carried out further conservation work, including injection grouting of voids between the brick support and the plaster using a commercially available grout;

filling of losses using a cement-lime-sand mixture; readhesion of flaking paint with a polyvinyl-butyl resin; consolidation and re-saturation of the surface with a dilute solution (less than 7 percent) of isobutyl and n-butyl methacrylate with ultraviolet-light stabilizers in solvent as an isolating layer; cleaning with an ammonium-citrate solution; and minimal inpainting using artists' matte fluid acrylic colors over the isolating layer in areas of damage (Fig. 3).<sup>13</sup> At the same time, the city undertook seismic retrofitting of the mural wall.<sup>14</sup>

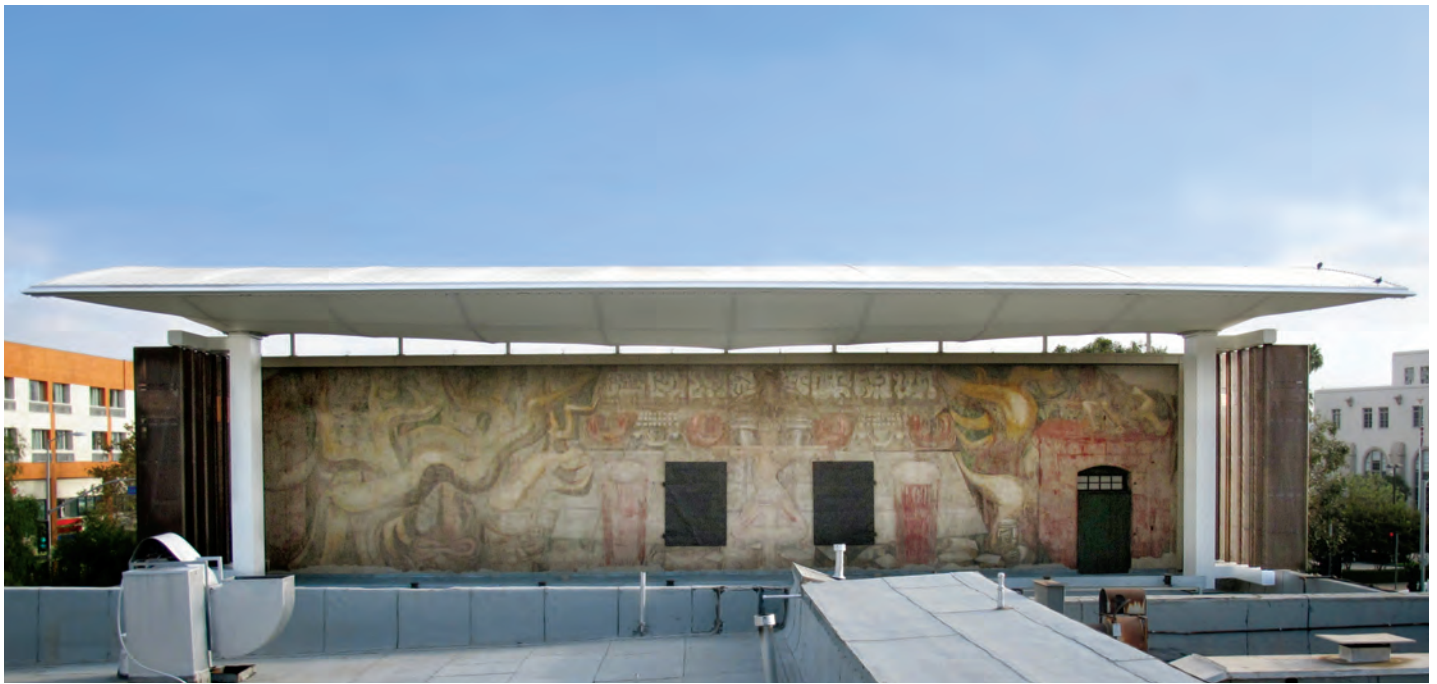
Fig. 4. View of *América Tropical* and the canopy shelter from a nearby rooftop. Photograph © J. Paul Getty Trust, 2012. Mural © 2012, Artists Rights Society (ARS), New York/Sociedad Mexicana de Autores de las Artes Plásticas (SOMAAP), Mexico City.

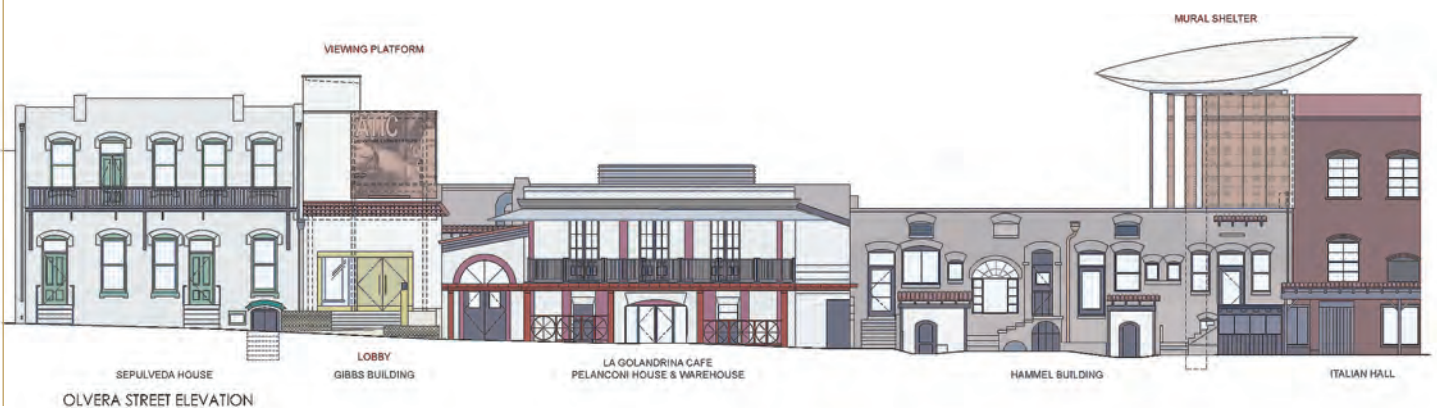
Fig. 5. Elevations of Main Street and Olvera Street, showing the profile of the canopy shelter and viewing platform. Drawing © Brooks + Scarpa Architects, 2009.

The historic fabric of the five masonry buildings within the site was preserved and/or rehabilitated observing best practices and guiding principles based on the *Secretary of the Interior's Standards*. The design of the shelter atop these historic buildings and within the historic context of Olvera Street adopted a contemporary architectural language whilst referencing the colors, urban texture, and features of the existing streetscape (Fig. 5).

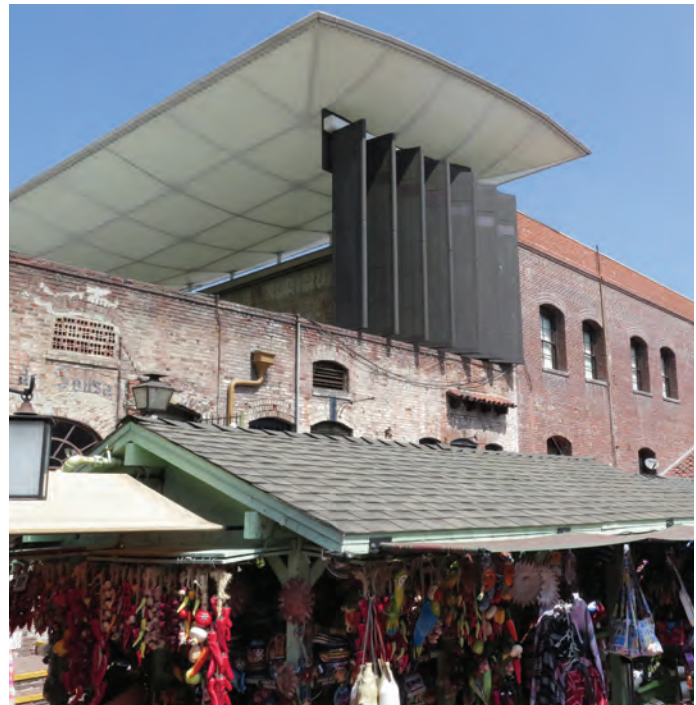
Fig. 6. View of the canopy shelter from Olvera Street, showing the vertical metal louvers, which provide protection from sunlight directly hitting the mural at the two sides and allow for a partial view of the mural and shelter from the street. Photograph © J. Paul Getty Trust, 2018.

The canopy and vertical louvers of the shelter protect the mural from direct sunlight and rain. The canopy consists of a two-way truss space frame, which is wrapped with fire-retardant fiberglass and polytetrafluoroethylene fabric stretched tightly over the frame and tapered toward the edges to visually reduce the apparent mass; there is a continuous “knife-edge” gutter at the perimeter. The louvers on each side consist of vertical panels, which are attached to the column construction; they extend in height from the parapet of the Hammel Building to just below the underside of the canopy.

Constructed of perforated copper, the louvers align with architectural elements of the adjacent Italian Hall. They are oriented at an oblique angle to protect the mural from direct sunlight coming in at the two sides (Fig. 6).

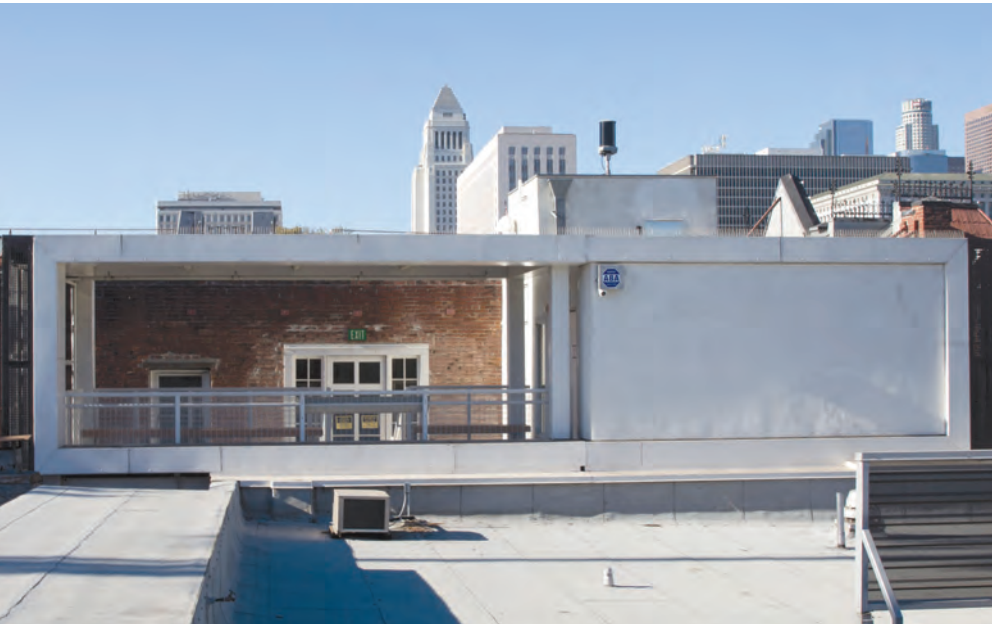
Fig. 7. Viewing platform, which provides visitors access to a nearby rooftop with an unobstructed view of the mural. Photograph © J. Paul Getty Trust, 2017.

An open-air viewing platform built in 2012 provides visitor access to a rooftop approximately 120 feet from the mural (Fig. 7). The placement of the viewing platform was dictated by building-code and engineering constraints, which did not allow for construction closer to the mural. These requirements included the need to comply with minimum distances to fire stairs and the need to minimize structural load to the existing historic buildings. The location selected also provided the best overall view of the mural. Contemporary in style, the rooftop addition announces the interpretive center below and provides shade for visitors while viewing the mural. An annotated, black-and-white historical photograph of the mural as it appeared in 1932 describes its composition to viewers.

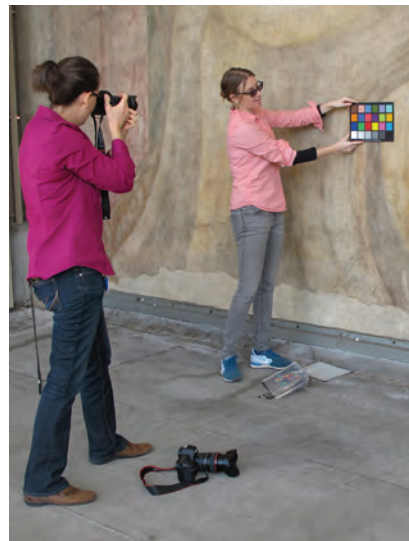
Fig. 8. Project team members carrying out monitoring of the mural as part of the GCI's 10-year post-treatment monitoring program. Monitoring is carried out on an annual basis to assess the condition of the mural and infrastructure. Photograph © J. Paul Getty Trust, 2015.

Monitoring of the mural includes visual inspection, graphic documentation, and photographic documentation of a set of monitoring locations on the wall (Fig. 8). These areas were selected to document color shift, both of original paint and areas of inpainting, flaking paint, dimensional change of cracks, reappearance of tar staining along the base of the wall, and new damage. The team prepares a report following each monitoring visit. Visits were carried out every six months for the first 18 months after the treatment in 2012, then annually thereafter.
